San Jacinto River Waste Pits Superfund Site

San Jacinto River Waste Pits Site

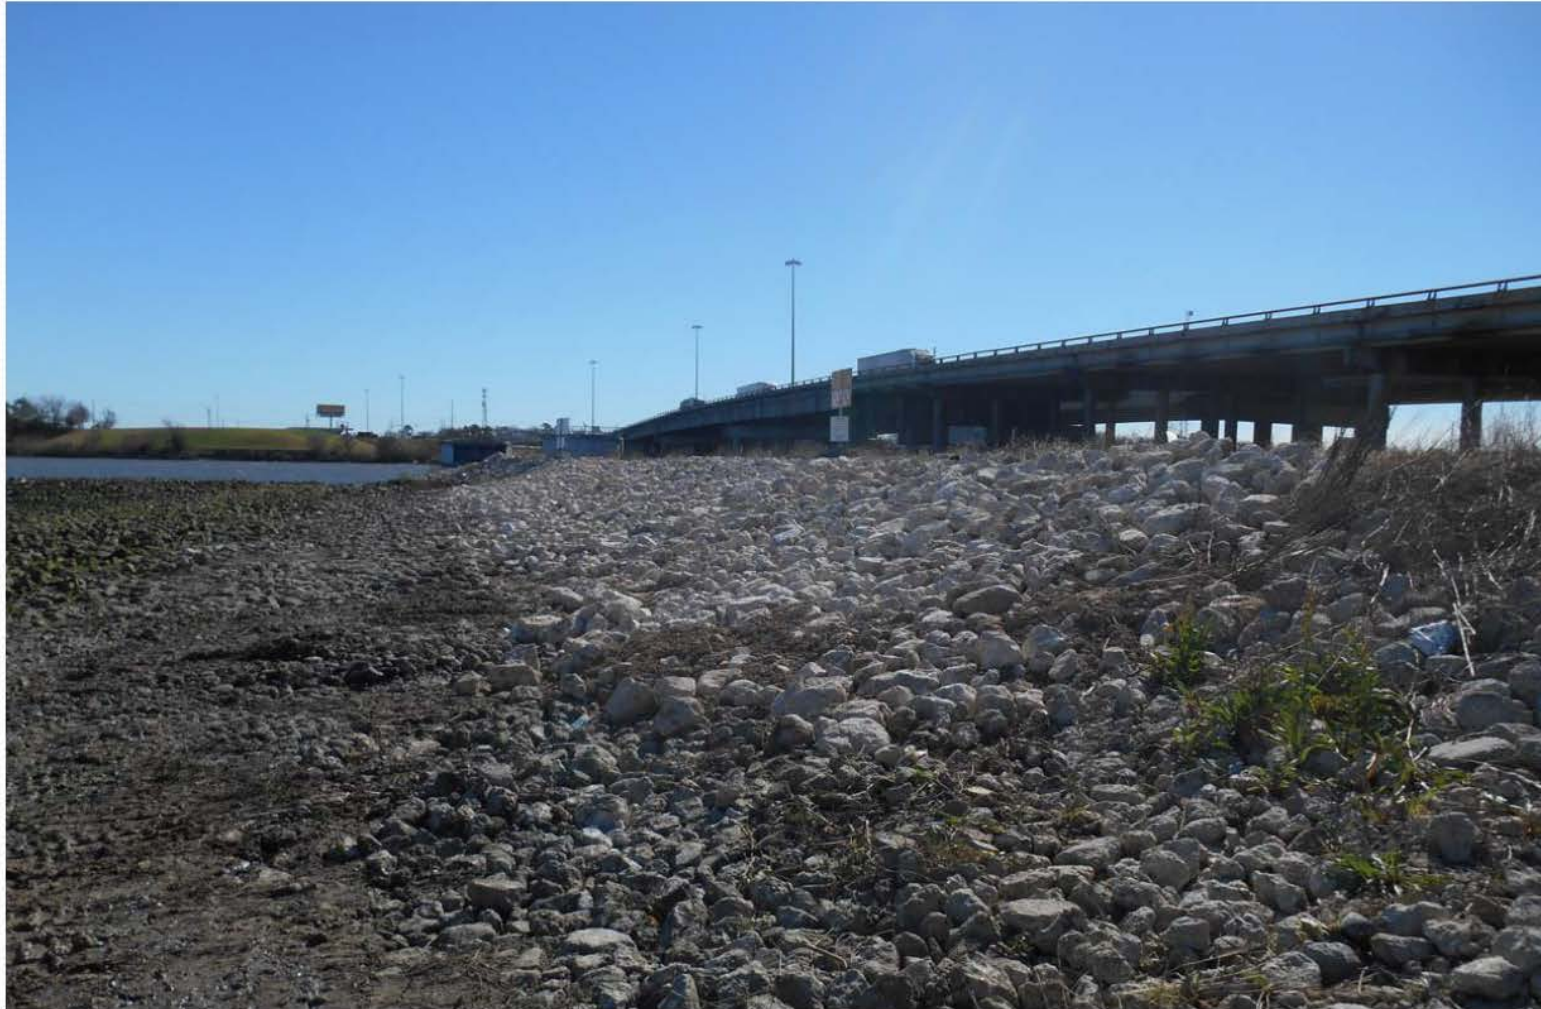
South Berm in the Eastern Cell after completion of the enhancement work 1-21-2014

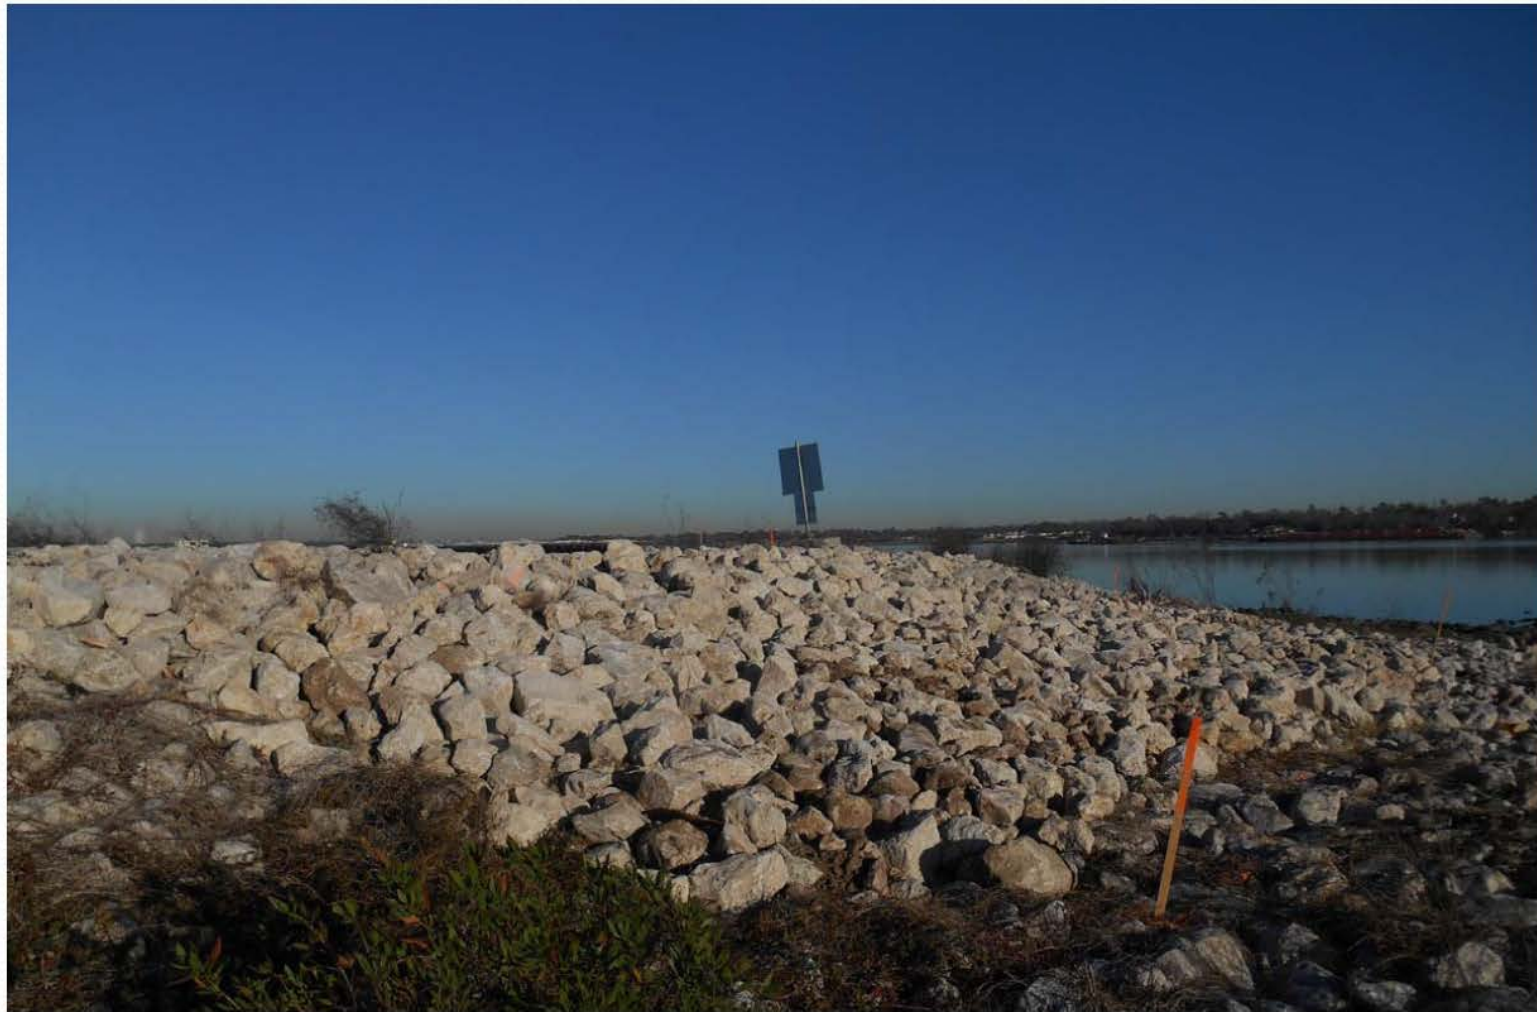
Central Berm on the eastern slope, near the north end of the berm, after completion of the enhancement work 1-22-2014
